**A PARCEL LONG LEASE LAND AND  
BUILT ON DWELLING, SITUATED AT  
PATIASTRAAT 15-C**

**"DRIVE BY" APPRAISAL REPORT 2025\_025**

**JANUARY 21, 2025**

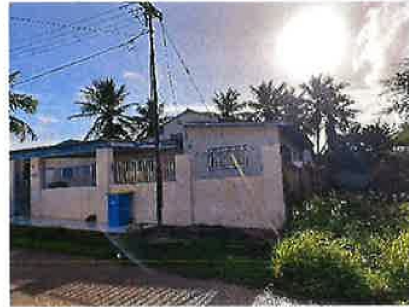
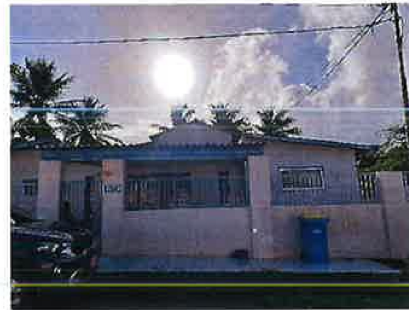
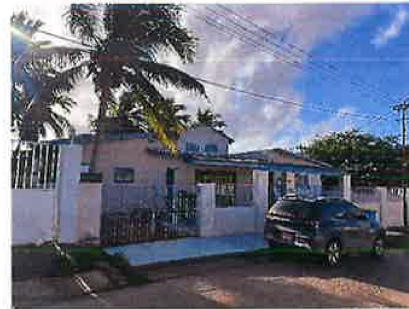
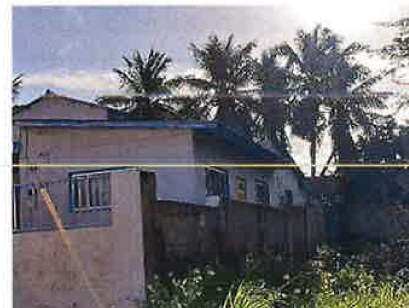
- The premises were inspected only on the outside
- Show several visible defects and the overall condition of maintenance, limited to the exterior, is moderate
- The premises appear to be occupied

- *The dwelling overall requires maintenance*
- Based on the maintenance condition on the outside, a similar condition is assumed for the inside

MAINTENANCE TABLE	N	G	S	M	I	P	U	Clarification
Foundation			X					
Floors			X					
Walls			X					
Roof								N/A
Frames, windows and doors								N/A
Floor and wall tiles								N/A
Ceiling								N/A
Painting				X	X			Exterior walls, windows, face board and fence wall require repainting
Kitchen								N/A
Bathroom fixtures								N/A
Plumbing								N/A
Electrical installation								N/A
Hardscape and/or landscaping								N/A
Fencing				X				Cracks in fence walls
<i>N: new (within 1 year after completion)</i> <i>G: good = as new</i> <i>S: sufficient = no maintenance excepted within 2 years</i> <i>M: moderate = maintenance excepted within 2 years (clarification)</i> <i>I: insufficient = maintenance / repair necessary (clarification)</i> <i>P: poor = replacement necessary (clarification)</i> <i>U: unfinished</i>
