**A PARCEL PROPERTY LAND AND
BUILT ON DWELLING,
SITUATED AT WESTSTRAAT 49**

“DRIVE BY” APPRAISAL REPORT 2024_507

OCTOBER 17, 2024

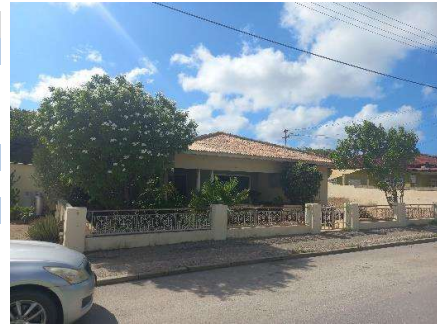
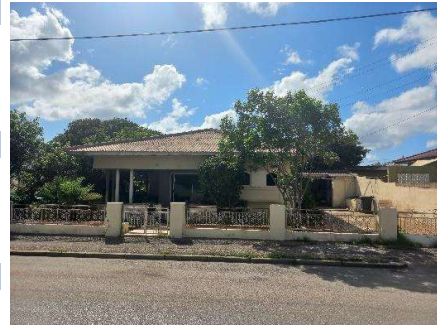
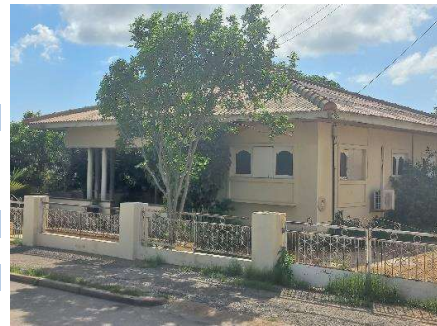
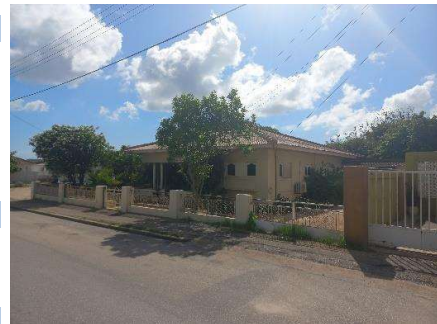
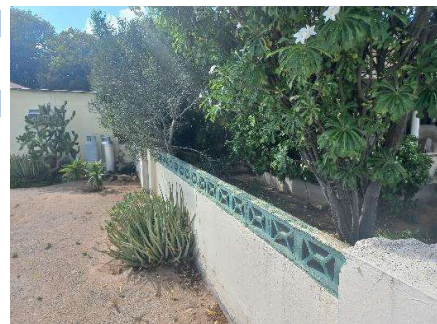
- The parcel is completely fenced off with
- Concrete block walls and concrete columns
- Plastered and painted
- At street side, metal fencing and ventilation blocks between columns
- Metal entrance gates

- A profound inspection of the premises was carried out, only from the outside
- Show several visible defects and the overall condition of maintenance, limited to the exterior, is moderate
- The house appears to be occupied
